**RE: NL Industries/Taracorp Superfund Site; Granite City, Illinois
Operation and Maintenance Inspection**

**NL Industries/Taracorp Superfund Site
O & M Inspection Log**

Date of Inspection: Friday, March 28, 2003

**NL/Taracorp Superfund Site
Operation and Maintenance Inspection Photographs – March 28, 2003**

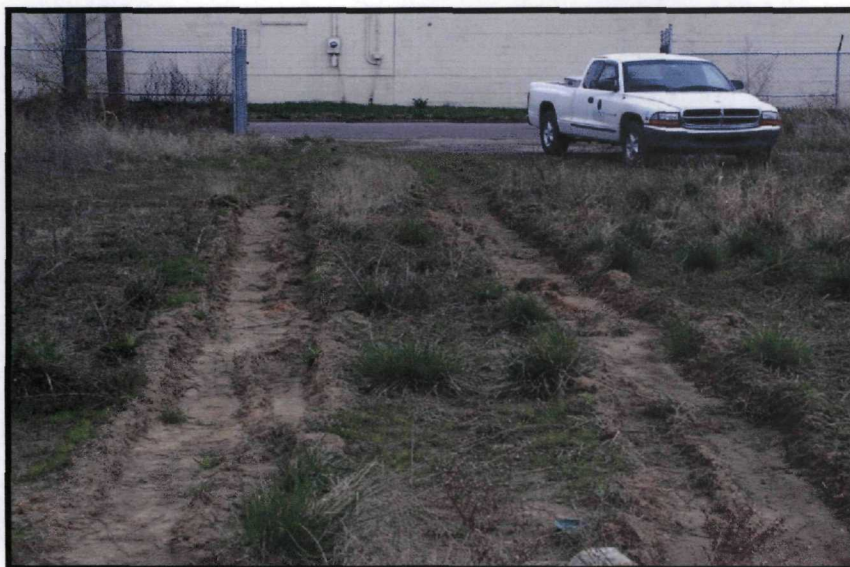
• Evidence of settlement or deterioration	Y	None	
• Comments		Fire Dept. truck ruts from State Street Gate to Large building (See photos)	
Landfill Cover – Vegetation

**Photograph 1
Access road ruts**

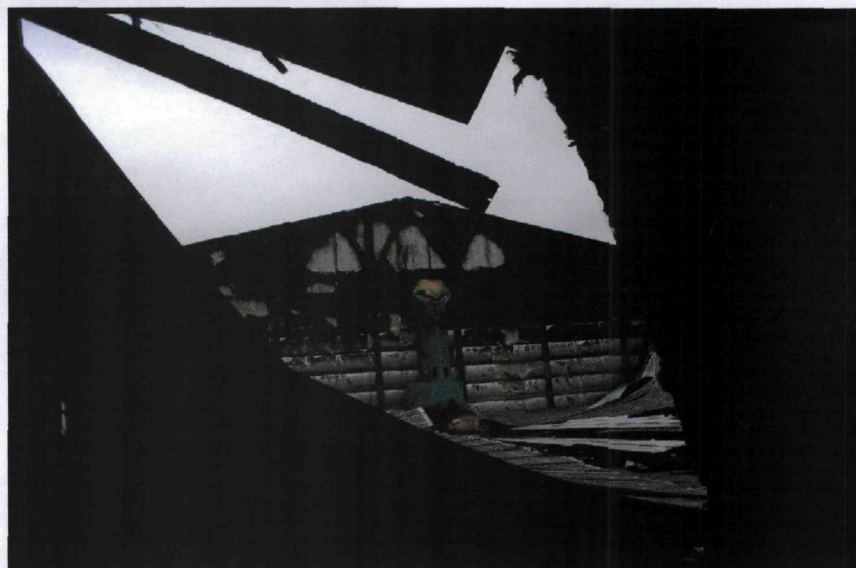
• Burrowing or tunneling under fence	Y	None	
• Damaged barbed wire	Y	Top wire of 3 down at SW corner	
• Comments		Anticipated Fire Dept emergency access through gate. Both buildings are destroyed and should be cleared from property. Large building is 95% burned.	Strongly recommend demo & disposal (see photos) Removal of storage building remnants will limit interest in site and eliminate future fence/gate damage.
Access Road:

**Photograph 2
Collapsed roof of
burned building**

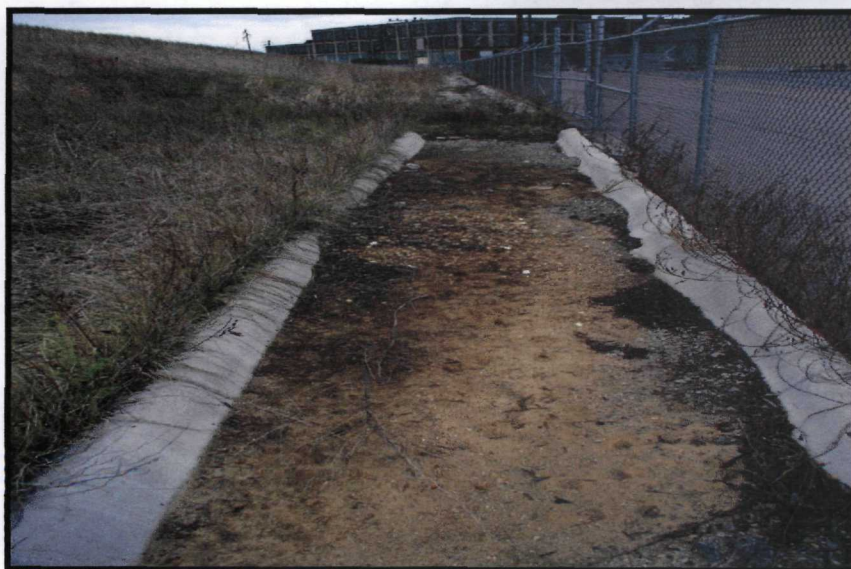
Site Structure	Inspected (Yes/No)	Inspection Observations	Maintenance Work Required or Performed
Concrete Drainage Channel			
• Evidence of cracks or obstructions	Y	No visible cracks. Minimal obstructions from erosion/run-off sediment. (see photos)	Recommend sweeping/pressure washing of concrete channel
• Areas of erosion	Y	None.	
• Comments			
Asphalt Covers - Integrity			
• Evidence of broken asphalt or fissures	Y	None.	
• Indicate areal extent and location	N/A		
• Comments

**Photograph 3
Channel debris**

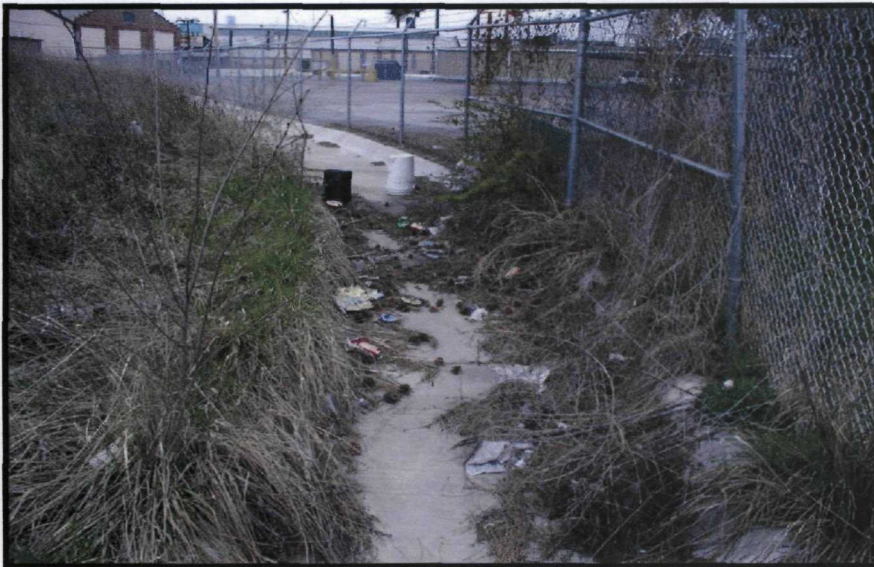
**Photograph 4
Channel debris**

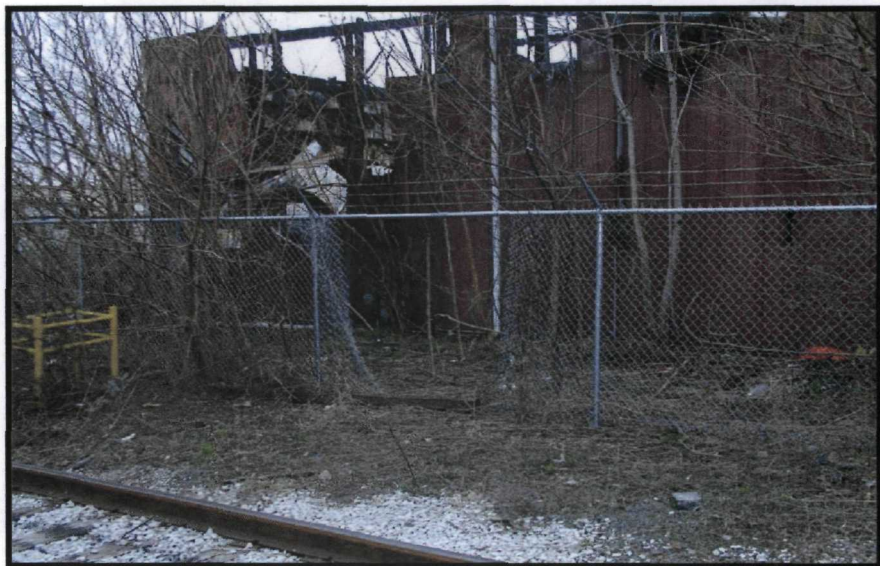
• Evidence of rust, cuts, deterioration	Y	None	
• Evidence of unauthorized entry	Y	Yes. Cut fence in 4 areas on East side near burned building. Fence down and 3 posts bent/broken on North. 1 Fence post broken on West.	Recommend Fence repair ASAP.

**Photograph 5
Cut fence on
northeast side**

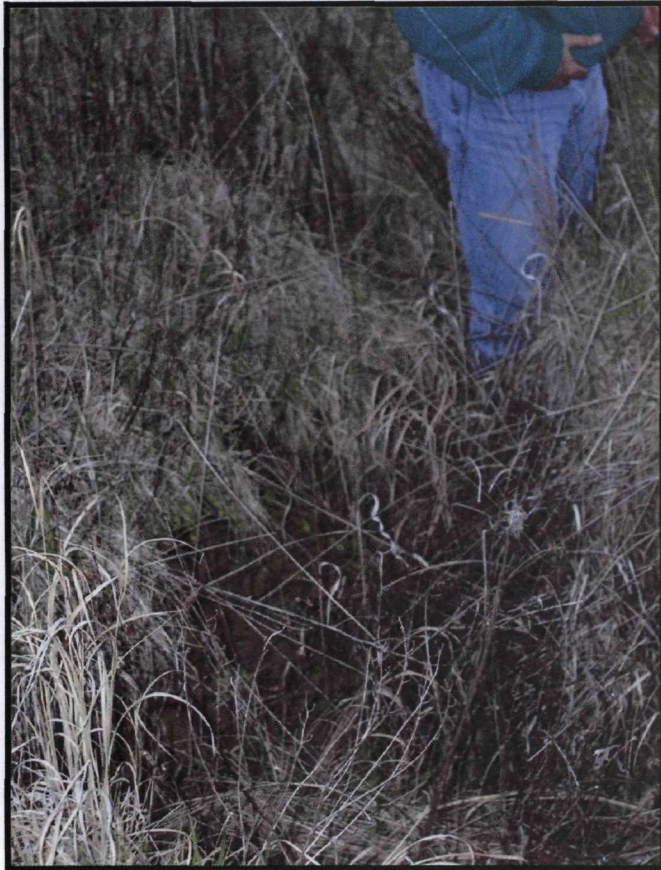
• Indicate areal extent and location	N/A		
• Comments			
Landfill Cover – Cracks			
• Evidence of cracks	Y	Erosion listed above. Cracks vary from 8" to 20" wide and vary from 6" to 36" deep.

• Indicate areal extent and location		Deepest crack are on West side from top of slope down to concrete channel.	Recommend maintenance soon to prevent further erosion.

**Photograph 6
Deepest crack – west side**

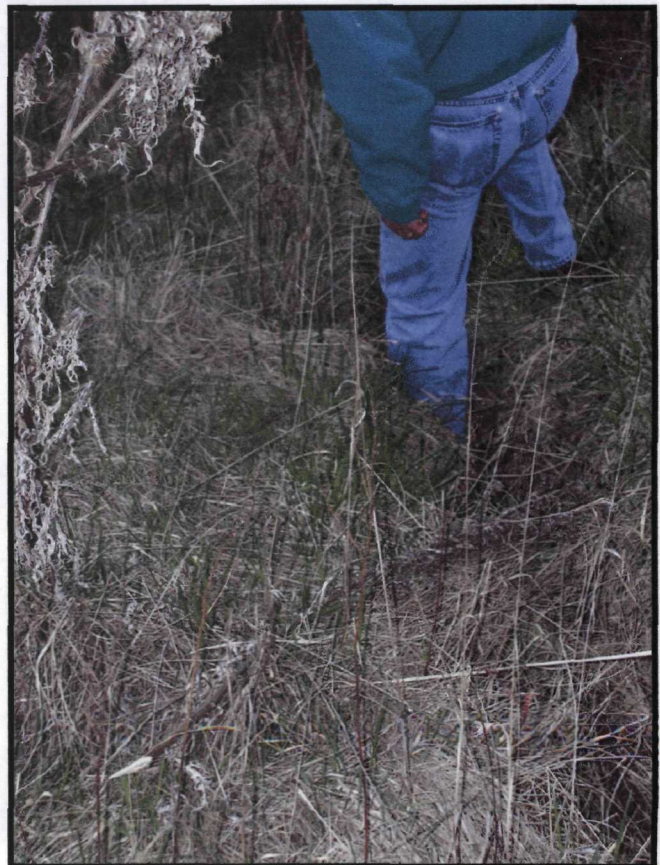
• Evidence of erosion	Y	Yes.	
• Indicate areal extent and location		6 locations on West side slope from top to concrete channel. 3 narrow & shallow areas on North and SE corner.	Recommend maintenance on West side to prevent further erosion.

**Photograph 7
Erosion crack – west side**

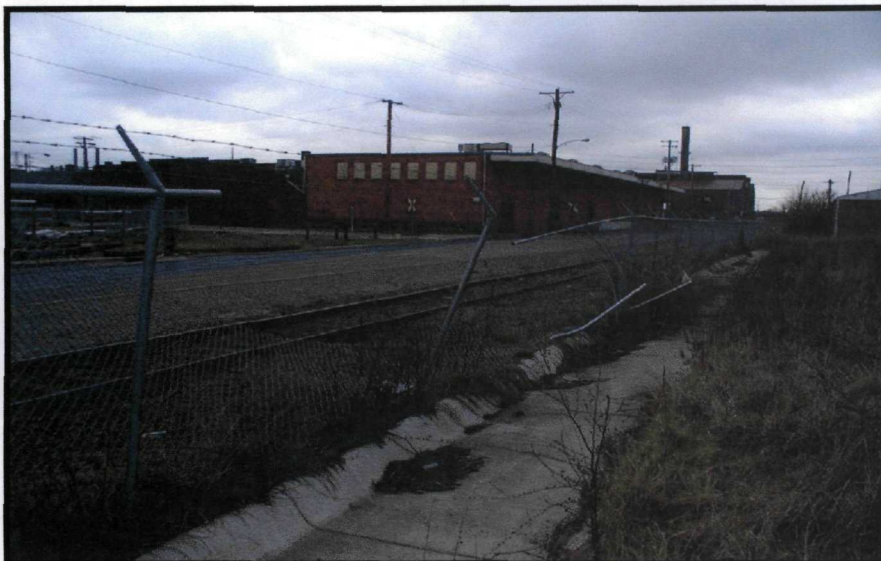
**Photograph 8
Fence damage on
northwest side of
site**

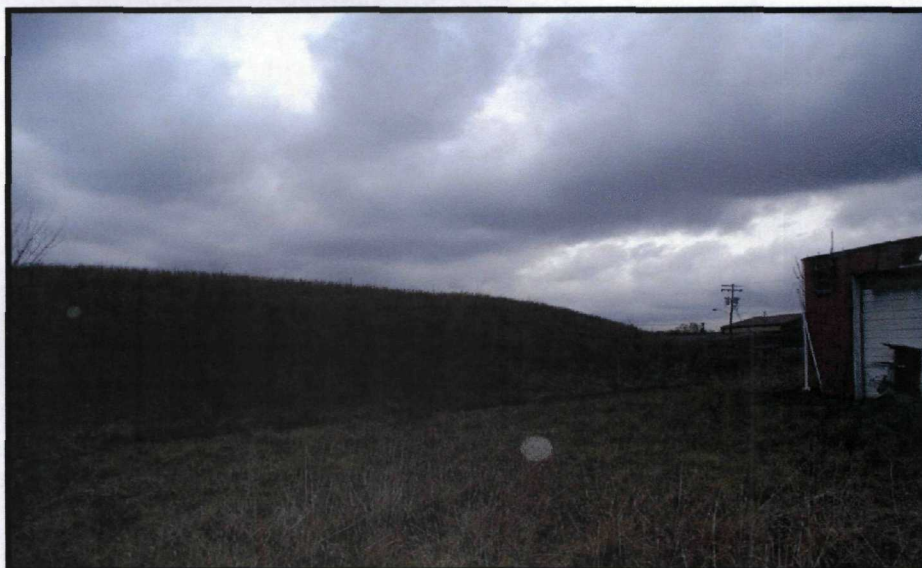
**Photograph 9
General – from
bottom looking
north**

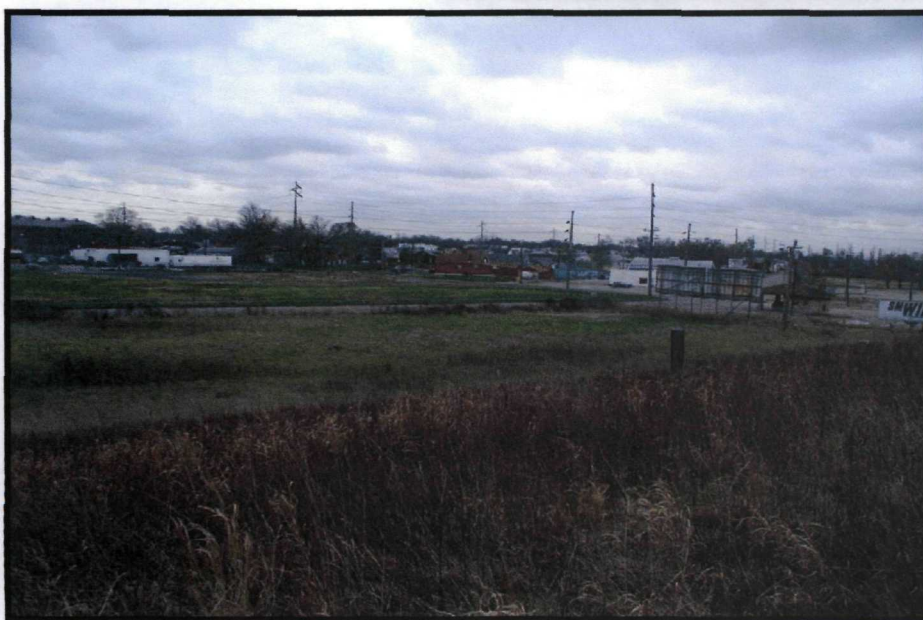
**Photograph 10
General – from top
down to drain**

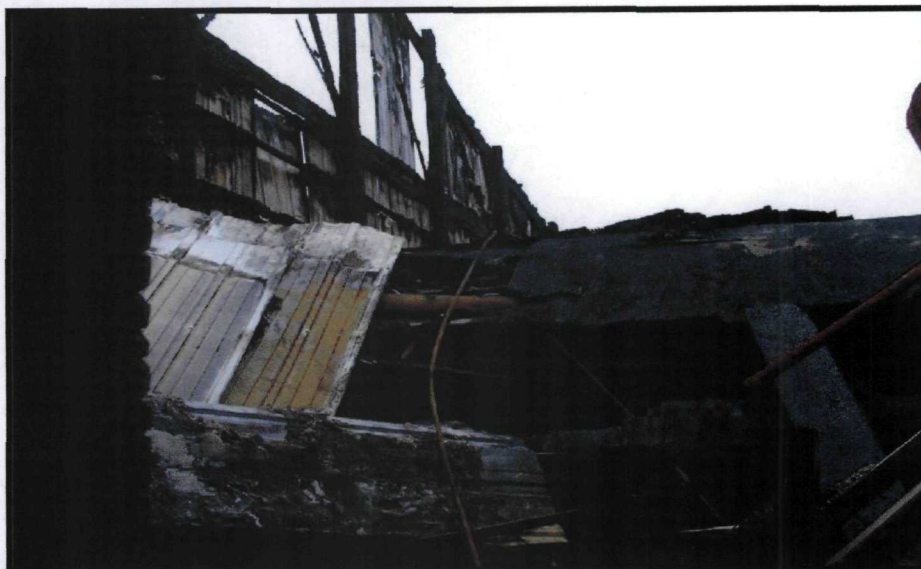
**Photograph 11
Inside burned
building**

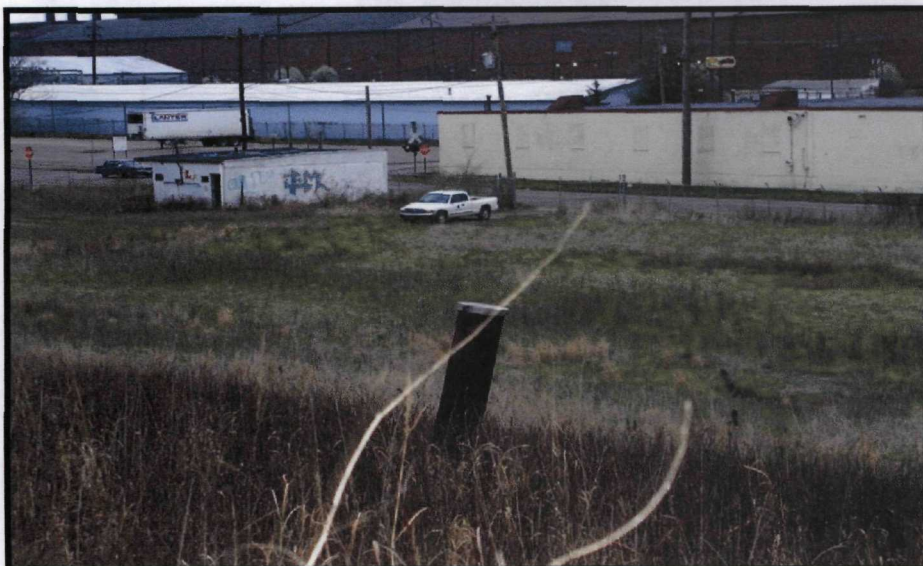
• Riser pipe and locks	Y	Riser pipe and cap in good condition. No lock	Recommend installing pad lock on cap.
• Leachate levels in sump	N		
• Necessary sampling activities	N

**Photograph 12
Leachate riser
and cap**

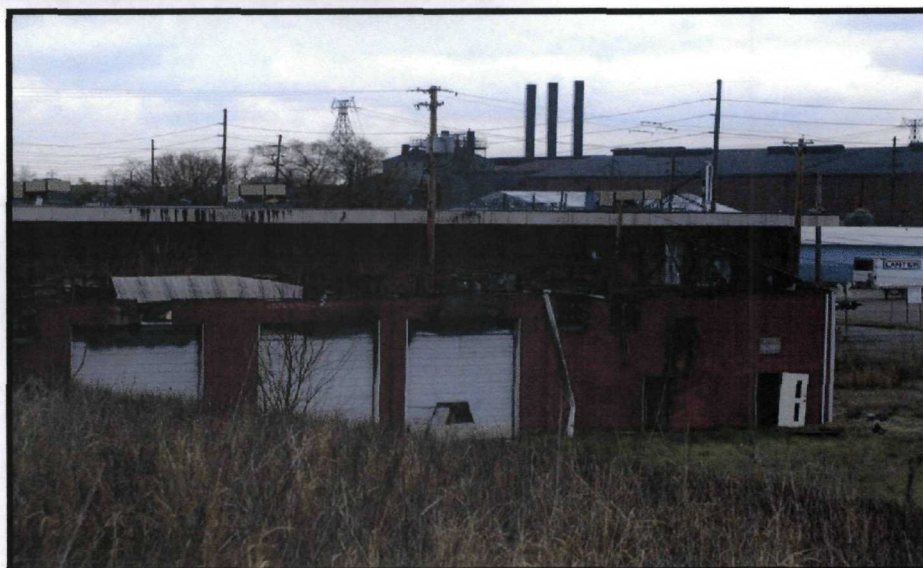
**Photograph 13
Outside of large
burned building**

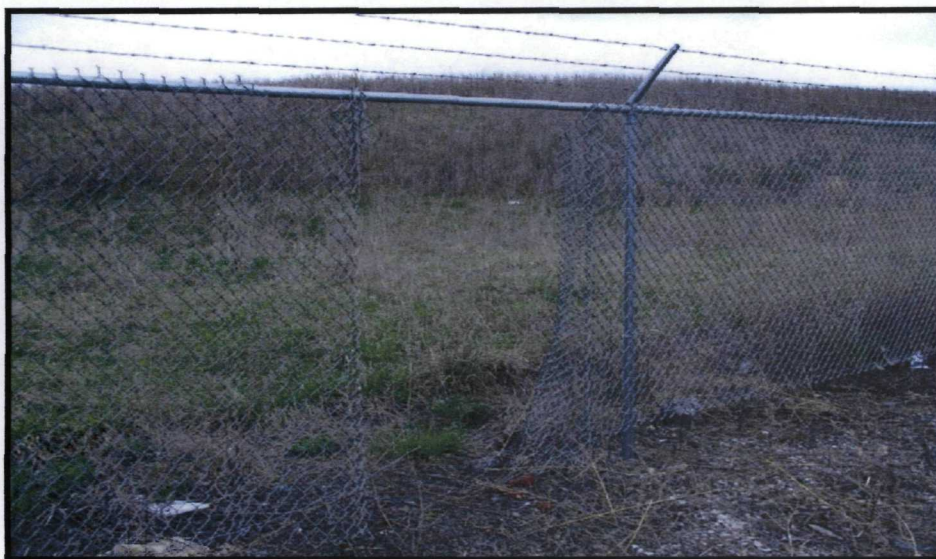
**Photograph 14
Cut fence on
east side of site**

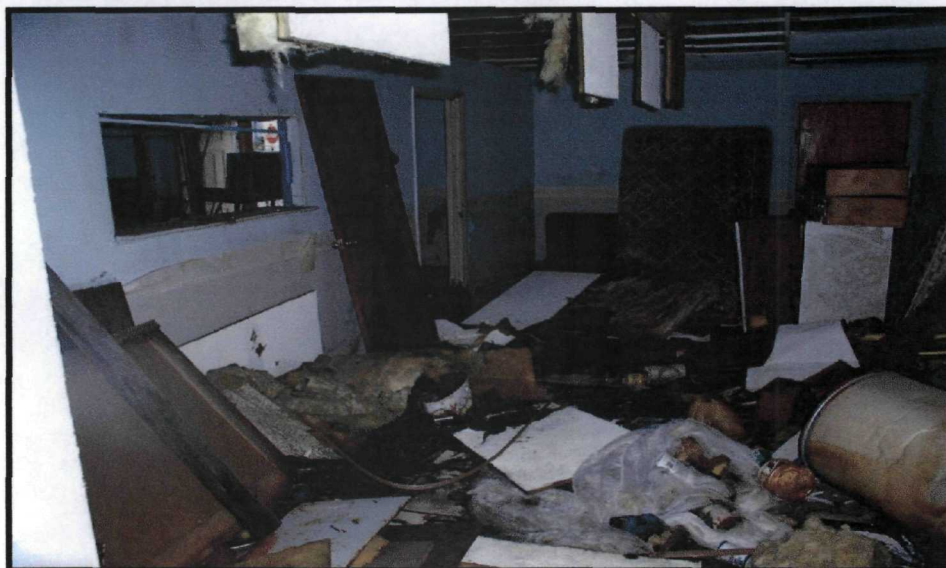
**Photograph 15
Inside of small
building**

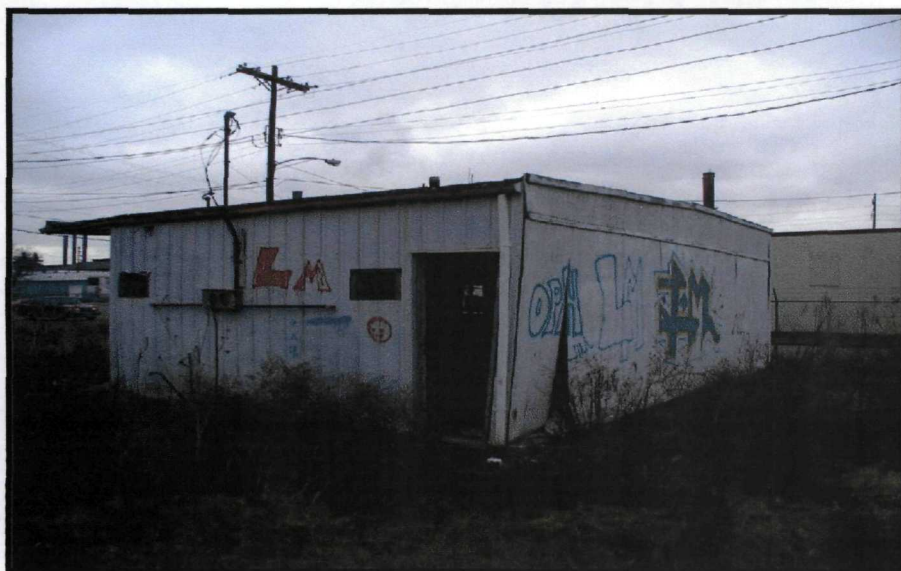
**Photograph 16
Outside of small
building**

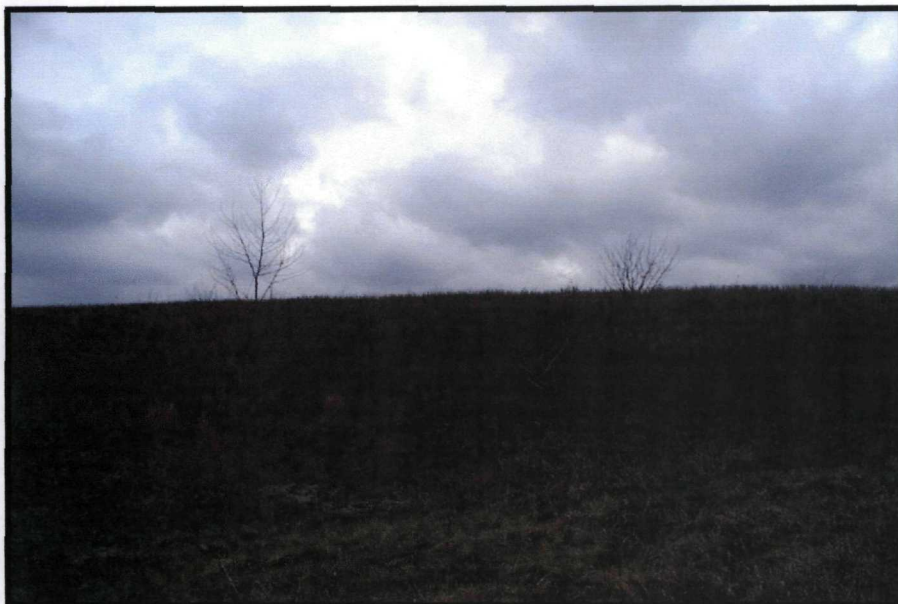
• Presence of trees/shrubs	Y	Many smaller trees. Several 5'-6' tall (see photo)	
• Need for mowing/maintenance	Y	No present need to mow.	
• Comments			
Landfill Cover – Erosion

**Photograph 17
Trees on Taracorp cap**

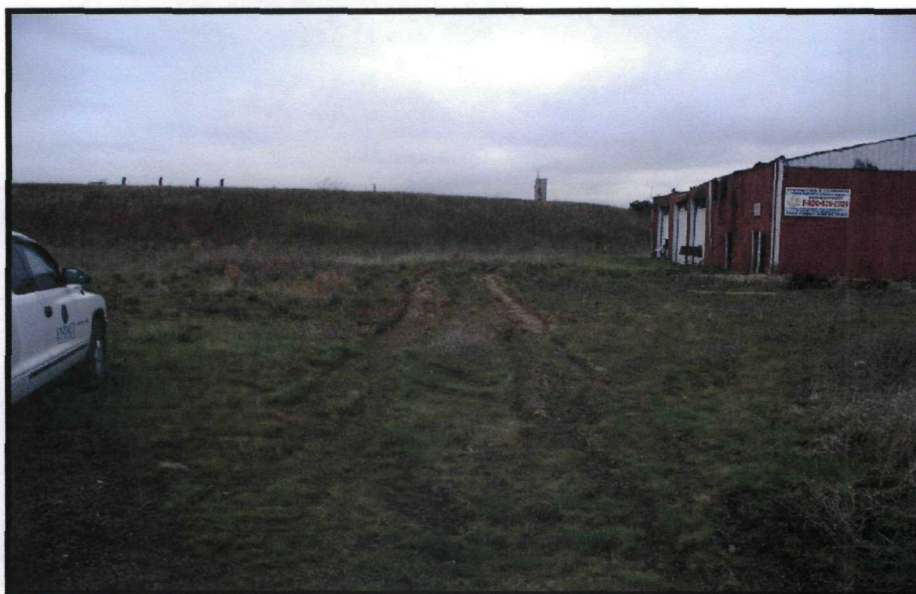
**Photograph 18
Truck ruts inside gate**
